SUBJECT: Coastside Design Review Continuance  
Cedar Street, Montara  
APN 036-132-210; County File No. PLN 2019-00362

**NEW CONSTRUCTION  
SINGLE FAMILY RESIDENCE  
TIM PATTERSON  
CEDAR STREET  
MONTARA, CA  
036-132-210**

## PATTERSON SFD Montara, California San Mateo County

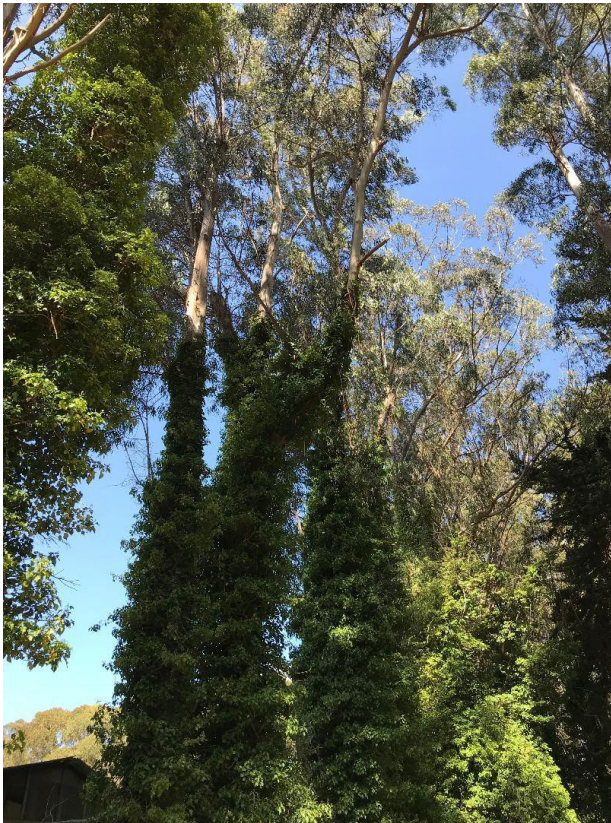
On the west side of the property, at the property line, is a large stand of mature blue gum eucalyptus trees. Ivy growth has taken over a majority of the trees, as ivy can be seen at heights of 40 feet up the tree trunks. The majority of these trees are on the neighboring property or on the property line and can be considered shared trees. All of these trees are recommended to be heavily pruned using acceptable reduction cuts out on the ends of the limbs, to reduce the risk of a large branch failure. Both sides of the tree, on the property side and neighboring side, should be pruned so that the tree canopies do not become unbalanced. All ivy growth is also recommended to be removed. Root crown inspection are recommended for all of the eucalyptus trees at the property line. Any signs of root rot may raise the need for tree removal. If the adjacent neighbor agrees, the trees should be removed and replaced with a different species acceptable in the climate as they can all be considered hazardous by nature.

**Showing ivy growth on eucalyptus trees**

Removing the eucalyptus trees and replanting with a native species or a species that does good in a coastal setting would help return the site to a more native setting and alleviate the liabilities associated with the grove of eucalyptus.

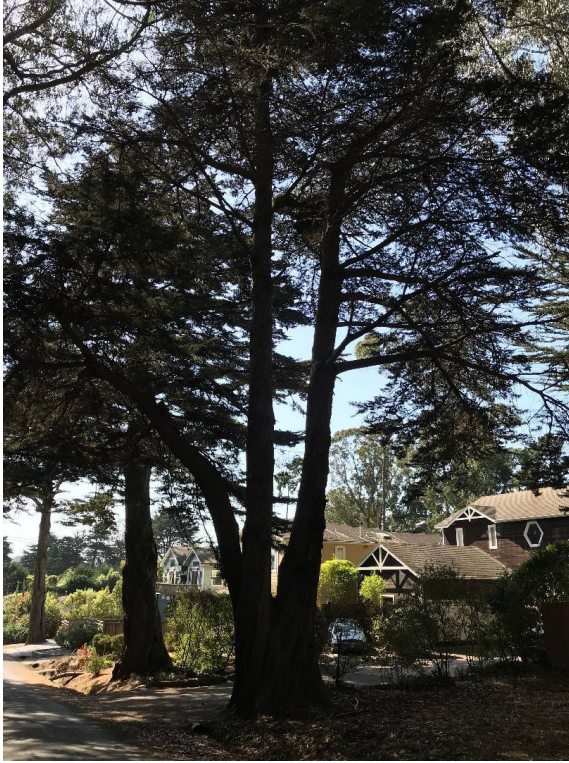
Large Monterey cypress trees #1 and #2 are in good condition. These trees are located on both sides of the existing entrance into the property (as well as the proposed driveway). These trees are both mature and have received pruning maintenance in the past. It is recommended to cable the leaders together on large cypress trees #1 and #2. These trees should receive pruning maintenance every 5-10 years, consisting of a general crown cleaning, as well as pruning to reduce risk of large branch failures.

**Showing large cypress trees #1 and #2**

The proposed parking areas when within 36 feet of cypress trees #1 and #2 must be on top of a landscape barrier to reduce risk of soil compaction within the root zone of cypress trees #1 and #2. Soil compaction is the leading cause of tree decline on construction sites as roots will die when soil is heavily compacted. Landscape barriers for vehicles shall consist of thick coarse

The proposed sewer line is 18 feet from cypress tree #1. This line is recommended to be excavated with the use of an air spade (air knife) in combination with hand tools when within 36 feet (6 times diameter) of cypress tree #1. All existing roots encountered within the trench must be exposed and remain as damage free as possible. The line must be tunneled underneath or between roots when possible. Root cutting shall stay as minimal as possible. The Project Arborist must be on site when excavation within 18 feet of this tree is to take place in order to document and inspect the work.

No roots shall be cut when within 18 feet (3 times diameter) of Monterey cypress tree #1 and #2 as these roots are critical for tree stability. The proposed driveway is located 7 feet from mature cypress tree #1 and 24 feet from cypress tree #2. It is recommended to construct the new driveway using biaxial geogrid (Tensar brand BX-1100) when within 36 feet (6 times diameter) of cypress tree #1 and #2. This geogrid can be pinned down over the existing soil surface as an underlayment which disperses loads laterally, and allows for building up a base section over the soil as a zero cut type driveway build. This will raise finished driveway grade elevation, but will also allow for thinning of the required base section thickness to as much as 50% below standard. Some initial grading will likely be needed to make a flat surface. Grading shall stay as minimal as possible. The maximum depth of excavation for the driveway allowed when within 18 feet from cypress tree #1 and #2 should be no greater than 4 inches. The Project Arborist must be on site to witness the construction of the driveway when within 36 feet of the cypress trees. Minor irrigation will be needed during the construction of the driveway. The top foot of soil shall be saturated in areas where no driveway will be located every 2 weeks during the construction of the driveway. Any roots to be exposed and retained or root ends that have been cut, must be wrapped in burlap and kept moist by keeping the burlap moist. If the above recommendations are followed, impacts to the trees are expected to be minor with no long term impacts.
